# Sacramento UNWI Sections 1 and 2 Project: Special Tunnel Construction with Plastic-Lined PCC Segments

**ABSTRACT:** The UNWI project was undertaken by Traylor Shea, a Joint Venture for the Sacramento Regional County Sanitation District. It features the first use of plastic-lined concrete segments in North America combined with rapid segment delivery and installation, tight curve radii, tunnel conveyor mucking and abbreviated startup. This inner lining prevents deterioration of the segments by corrosive sewer gases. Once the segments are in place, the joints between segments are heat-sealed together to form a complete liner. Unique solutions were devised to protect the plastic lining without sacrificing the high performance objectives of the system or the safety of the crew.

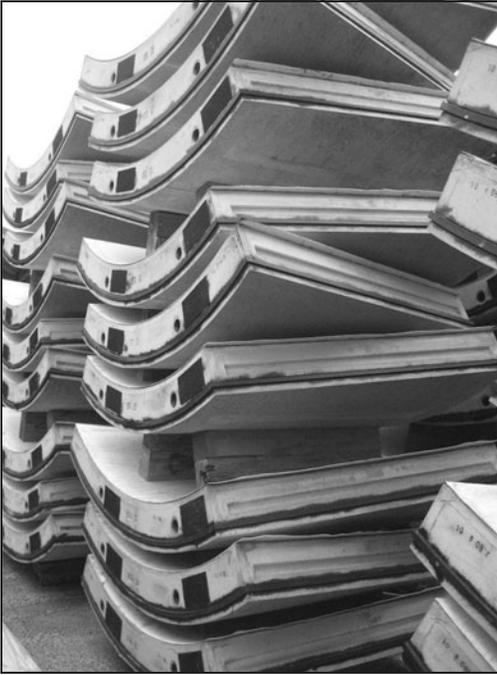
**Figure 1. PVC lined segments with flaps**

The PVC lining was embedded into the concrete I.D. of the segments and once the segments were installed the liner was fully heat welded to ensure a continuous “pinhole free” liner. The Traylor-Shea Joint Venture designed the precast concrete segments to accommodate flaps overhanging the edge of the segments. These flaps were incorporated to facilitate welding one segment to the next and to minimize the PVC welding materials and labor needed. Once the segments were erected and grouted in place, the joints or flap edges were joined using a separate welding strip. The welding strips were applied manually using electric heat guns (see Figures 1–2). The strips melted with the application of heat and the molten material created the bond.

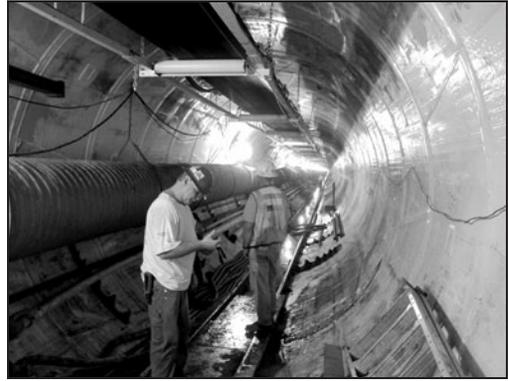
**Figure 2. Sealed radial and circumferential joints**

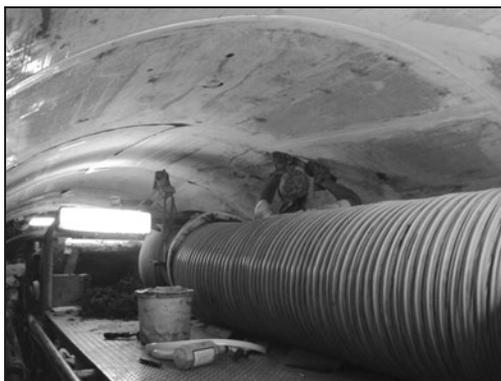
**Figure 3. Work area with fresh air duct**

A dedicated workdeck was also installed in the same area of the TBM, immediately behind the discharge chute of the screw conveyor. This deck, along with numerous welding gun power takeoffs, proper lighting and storage areas to support the welding operation, was used to weld all the PVC joints in the upper portion of the tunnel. It was critical to the process as it allowed the only access to the crown before it was blocked by installation of the mainline conveyor. As it was the only possible location, the welding process had to share the work deck area with the fresh air duct. The duct was made flexible so that it could be pushed from side to side to access the entire crown. In this way, the 15' long deck provided sufficient access to this area of the tunnel to allow efficient welding of the joints as the tunnel advanced (see Figure 3).

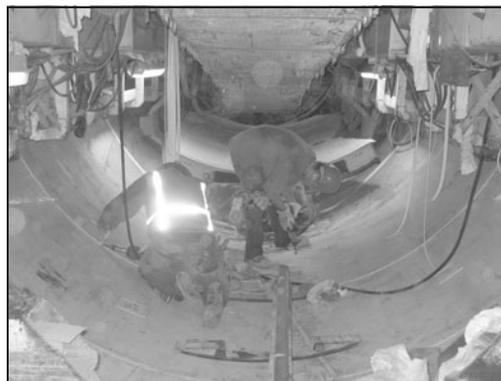
**Figure 4. Heat welding of seams**

reach. The Resident Engineer's tunnel inspection team provided oversight of the process as well as proof testing of the welds using rounded-edge putty knives. Traylor Shea provided testing checks of the welds using Tinker Razor spark testing devices. Final testing and repairs remained to be completed at the time of this writing (see Figure 4).

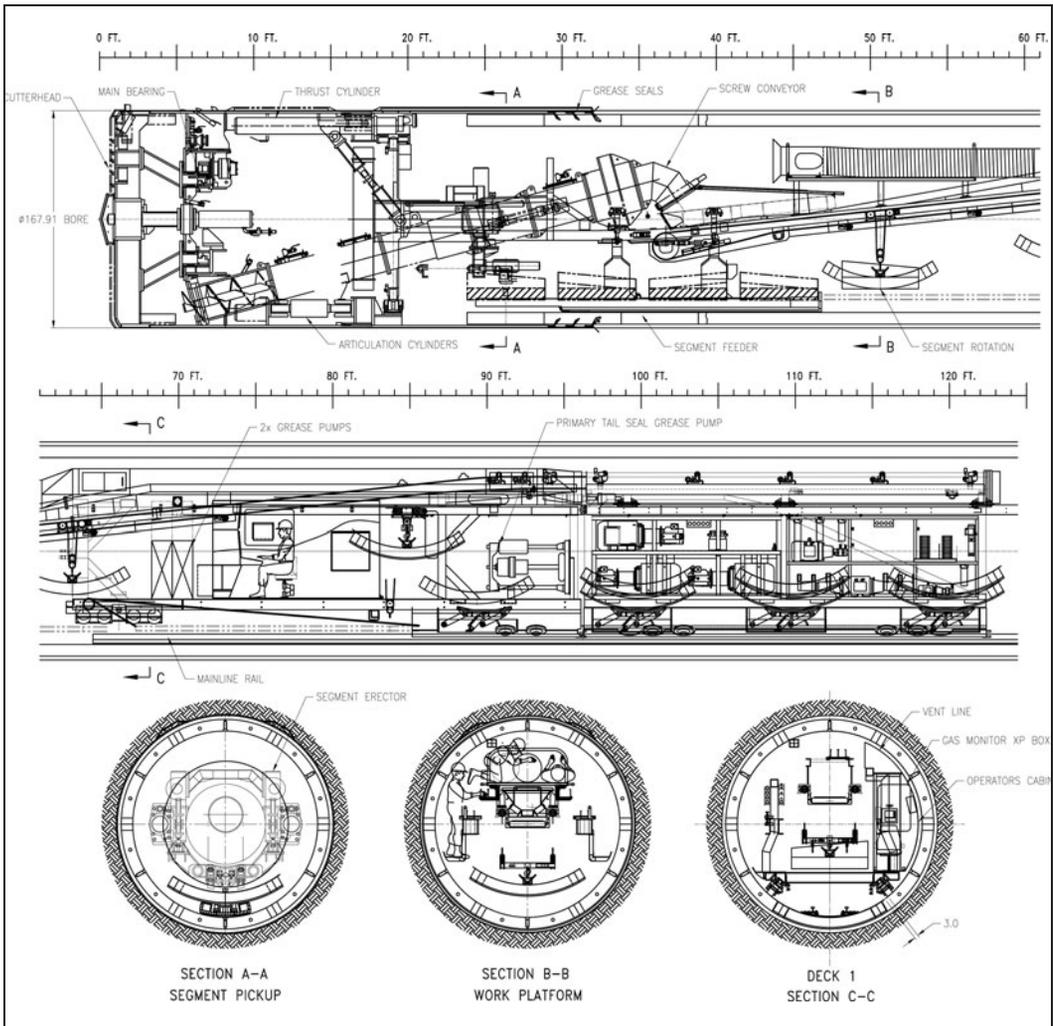
**Figure 5. TBM general assembly**

The remedy was to implement a system which included segment lifters and a segment feeder. The segment lifters allowed the two rings worth of segments to be offloaded and stored on the backup in an instant, allowing the trains to immediately return to pick up another load. The feeder stored enough rings immediately behind the erector to keep it supplied, even though the erector used segments faster than the trolley could bring them. The feeder became depleted at the end of each build but there was enough time to refill it during the push. (see Figure 5)

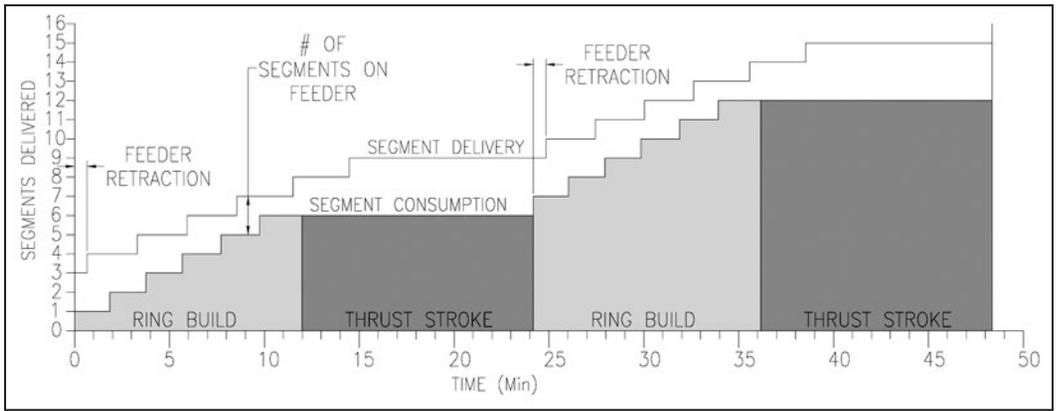
Figure 6. Segment building time diagram

The time study, shown in Figure 6, was used to determine the speed and capacity parameters for the segment lifters, hoist and feeder. The cycle time was designed to allow both the advance of the TBM and erection of the 6-piece segmental liner in an approximately 30 minute timeframe, which was composed of 15 minutes of ring building and 15 minutes of mining. This cycle resulted in a segment feeder capacity of three segments. To ensure an uninterrupted supply of segments, four sets of segment lifters were included in the backup design to collectively handle 2 complete rings.

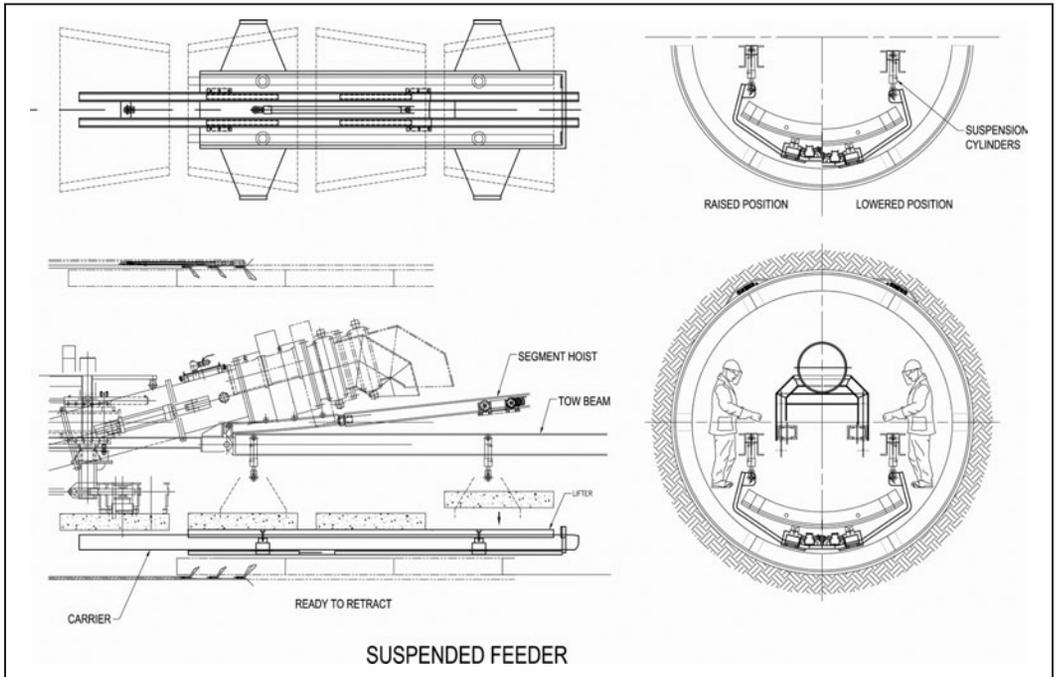
Figure 7. Segment feeder diagram

sharp curves as well as the PVC flap on the segment. To provide the maximum clearance for the extended segment with the erector pickup head, the feeder was suspended on four hydraulic cylinders. These lifted the feeder off of the lining for the push but lowered it again prior to feeder extension. This design prevented the suspension system from being damaged in the event that the erector pickup was accidentally extended instead of retracted when picking up the segments (see Figures 7–8).

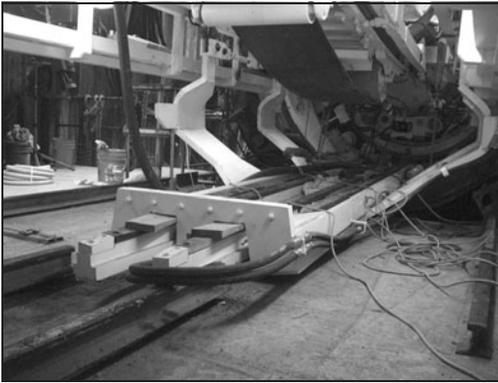
**Figure 8. Installed segment feeder**

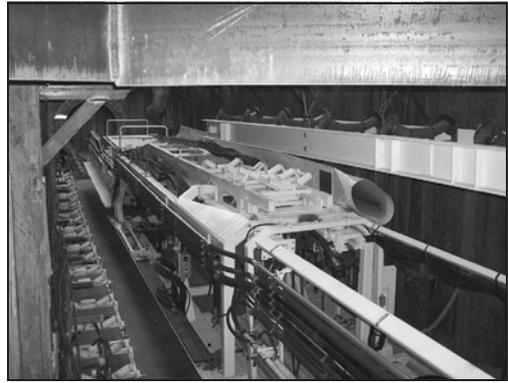
**Figure 9. Abbreviated startup configuration**

distance. This was initially expected to be sufficient for the bridge and three decks behind the TBM, as there was 25 ft between the TBM and deck 1. Four decks would contain all of the hydraulics but none of the electrical. However, the 25 ft space between TBM and backup was barely sufficient for a short feeder and the installation of half length rails (16.5 ft). Though beneficial for startup, this short arrangement would have been a handicap for the remainder of tunneling. The development of a started tunnel was

not practical in the pressurized soil environment and so the most compact starting arrangement had to be devised while still preserving efficient segment storage as well as the ability to set full length (33 ft) rails (see Figure 9).

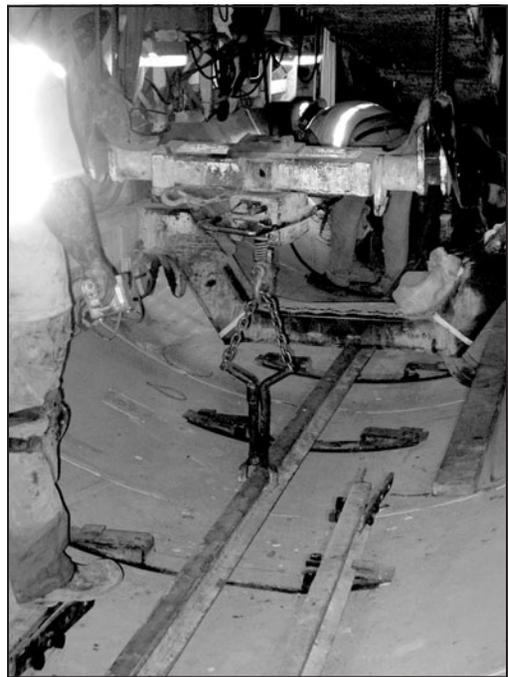
**Figure 10. Track laying process**

The 33 ft rail requirement, together with the short startup, meant that the rail setting activity would have to take place mostly within the length of deck 1. In order for this to occur, the forward portion of the bottom deck needed to be open. Having both the top and bottom of the deck open at the front would have been ideal from a functional point of view. It was, however found to be impractical from a structural point of view. With an open bottom the front wheels had to contact the tunnel walls at about 4:00 and 8:00. This created additional inward forces, which would have acted to collapse the C shaped deck. In the end a transverse brace was added to the bottom deck at the front. The brace made setting the rail more challenging but still practical. This brace was later lowered to make it less of an obstruction to foot traffic while still allowing rail installation (see Figures 10–11).

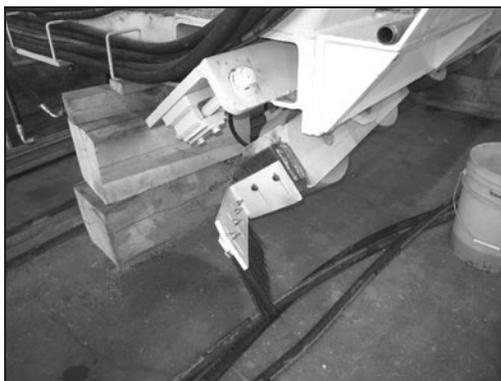
**Figure 11. Elastomeric wheel assemblies with brushes and adjustable alignment**

Beyond minimizing the wheel load, bogies were designed to fully equalize the wheel loading. This meant that each two-wheel bogie was mounted on a center pivot. The two bogies were then mounted on a larger bogie which itself had a center pivot connecting it to the deck. In addition, the front wheel assemblies featured adjustable alignment to minimize skidding.

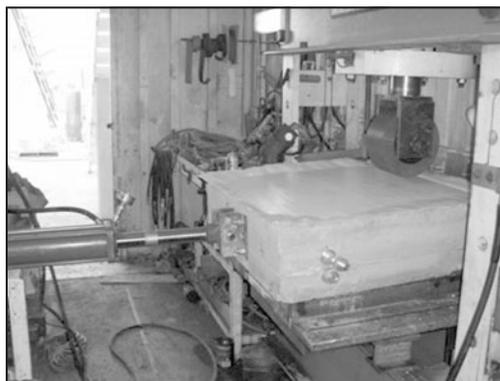
**Figure 12. PVC liner testing**

for the particular wheel type used. Traylor Shea JV performed loading testing of elastomeric wheels on the Ameron T-lock sheets to determine loading limits and prevent damage. The testing was carried out on site using 60 durometer urethane wheels left over from previous projects. The wheels were tested by pressing the wheel into the PVC sheet, which was then held for up to 24 hour increments using hydraulic cylinders to apply varying loading. The testing resulted in a contact pressure of 1,000 psi, or about 6,000 pounds of force per wheel. Once the critical loading pressure was determined, a series of tests were performed to determine any damage caused by movement of the wheels under the high pressures, namely rolling damage and damage caused by embedded grit from a dirty liner. Traylor Shea determined that the sideways loading on the wheel edges did not damage the PVC liner. However, dirt and debris on the PVC sheet caused very serious damage to the liner as the loaded wheel pressed the grit into the sheet. This caused enough damage to result in a failed spark test. Once this analysis was performed and the results realized, a cleaning system in front of the urethane gantry wheels was deemed to be necessary. TSJV recommended that brushes or air puffers be used to push any such material out of the path of the wheels. Brushes were ultimately supplied. Throughout the tunnel drive the brushes provided adequate cleaning capability to prevent debris from become embedded in the liner (see Figure 12).

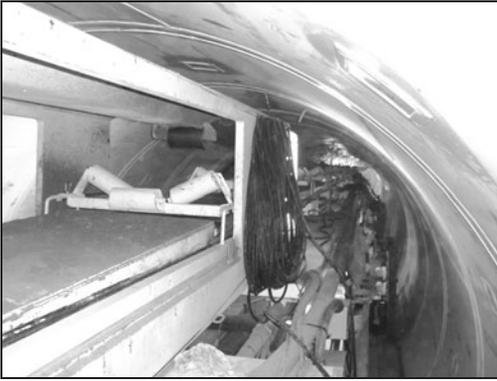
**Figure 13. Rear PVC welding station and continuous conveyor tailpiece**

Combining the two conveyors can be beneficial in that it allows at least one, and possibly two, transfer points to be eliminated. In small tunnels, the head room saved through the elimination of a transfer point can be very valuable. This was the arrangement used on the UNWI project. Due to space constraints, the segment hoist, bridge conveyor and continuous conveyor were integrated into a single unit. A consequence of the design was that the return pulley, just under the TBM discharge, was much larger than it would otherwise be. This cramped the space for bypassing the feeder with the segment but was still utilized successfully.

At the tailpiece, the vent ducts were run downward into deck structure below to allow unobstructed access to the tailpiece. This design also provided for better access to the PVC lining for welding.
