Challenging mixed face tunneling at India's Sleemanabad Carrier Canal

J. Clark

The Robbins Company, New Delhi, India

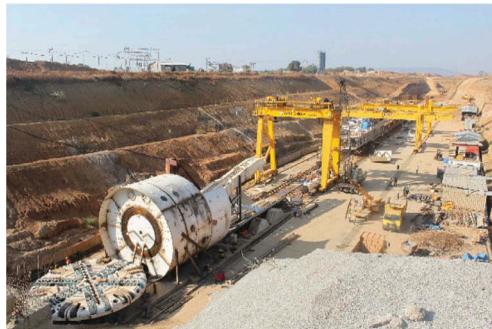
Figure 3. Onsite TBM assembly.

The machine was assembled at the remote jobsite using Onsite First Time Assembly (OFTA), a method that allows for the machine to be initially assembled on location with testing of critical sub-assemblies in a workshop. The TBM was launched in early March 2011 in EPB mode with a full dress of soft ground tools as the geological information indicated mainly soft ground for the initial 500 m of boring. During the first 200 m of boring the TBM encountered mixed

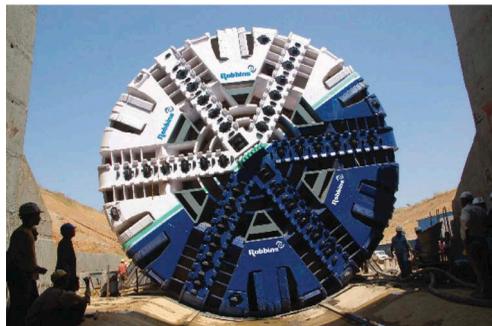
Figure 4. TBM launch.

geology containing residual soils and hard rock. This was the first of frequent changes in geological conditions that were encountered during the initial 1,600 m of boring. The strength of the rock dictated that the soft ground tools needed to be replaced with disc cutters. After changing out the cutter tools, the machine was boring in rock but still had to be operated in closed/EPB mode to prevent settlement of the soil above the crown of the tunnel (see Figures 3-4).

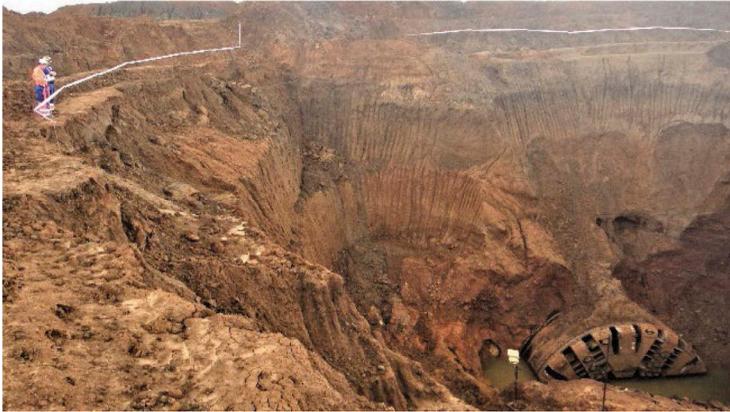
Figure 5. Excavation down to the TBM.

Due to a lack of timely cutterhead interventions the cutterhead suffered wear damage to an extent that required repairs on three separate occasions. Because of the low overburden and mixed geological conditions, it was decided that excavation from the surface down to the TBM would be far easier than creating a subsurface chamber to carry out the repairs. Neither shaft segments nor piling equipment were available at site, but heavy earth moving equipment was being utilized on the canal works. The availability of this equipment made it possible to create an open pit type excavation (see Figure 5).

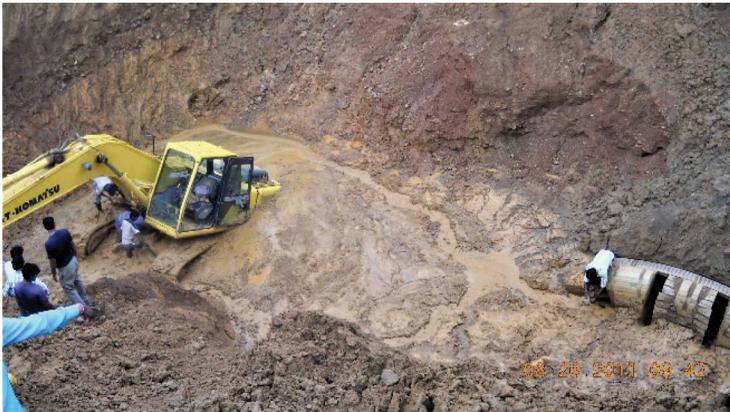
Figure 6. Liquefaction of the soils.

The residual soils and alluvial material were relatively easy to excavate but their low cohesion called for a multi-level pit with several benches and involved the excavation of around 30,000 m³ of material. One of the problems faced during excavation of the open pits was liquefaction caused by the saturated nature of the soil and vibration of the excavation equipment (see Figure 6).

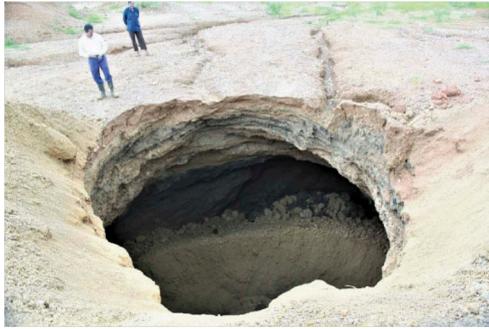
Figure 7. Sinkhole above the machine.

A problem related to the failed cutterhead interventions was sinkholes appearing above the machine (see Figure 7). Several interventions were aborted up to 48 hours after they commenced due to progressive increase in air losses. It became standard practice to reduce hyperbaric pressure to a minimum (approx. 0.9 bar) to reduce the amount of air losses; hence, this also extended the

The bore diameter of the cutterhead with new cutters is 10.0 m, whereas the outer diameter of the TBM shields is 9.93 m (the differential is required for steering purposes and is standard design practice). The combined length of the TBM shields is 11.2 m which equates to 12.3 m³ of annular space around the shields. When sufficient face pressure is maintained, the risk of convergence is minimized, but reducing the pressure allowed convergence to occur. The combination of inflow of fines into the chamber and convergence around the annular gap led to cavities forming over the cutterhead and shields and ultimately unravelling up to the surface. The sinkholes generally occurred once the machine had advanced 2-3 rings after the intervention had been completed. The section where the sinkholes occurred is part of the 95% of the tunnel alignment that runs beneath agricultural land, so there was no risk to surface structures. Access to the land over the first 1.5 km of tunnel was relatively straightforward, so earth moving equipment was deployed to backfill the sink holes. Usually after less than 24 hours boring was able to continue.
